## Pre-Buy Inspection For LifeStyle Aviation

**Burlington, VT - September 26-27, 2025**

**Aircraft:** Tecnam P-Mentor

**Tail Number:** N223PM

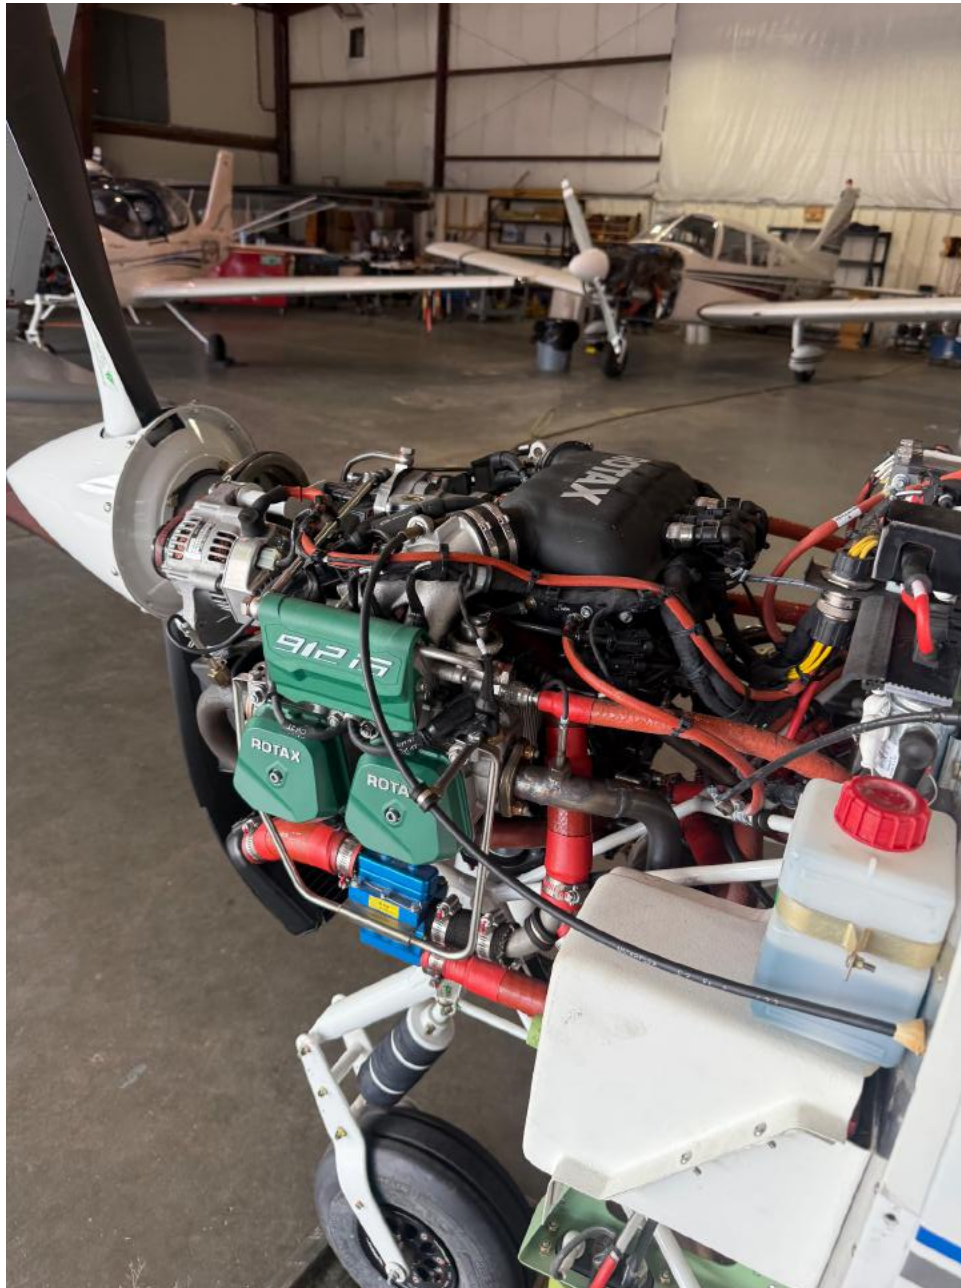
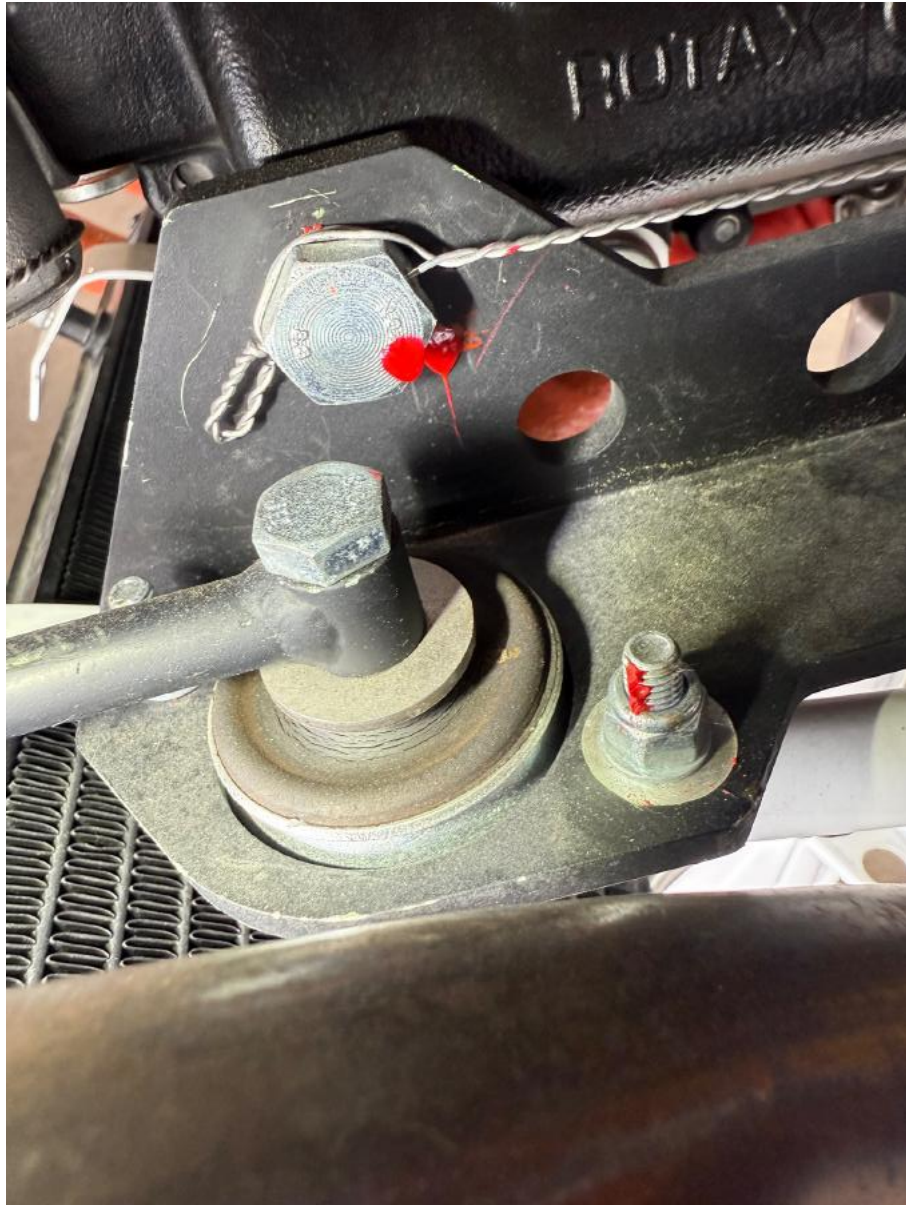
- Tecnam Job Card for engine mount tube protection complied with. No chafing present; protective sleeves undamaged.
- Engine exceptionally clean and dry. No oil leaks observed anywhere.
- Oil cooler in excellent condition. Fire sleeved hoses appear nearly new.
- Exhaust system: muffler replaced as per logbooks; no active leaks. Old lead staining present only as historical residue.
- Cooling system: radiators in excellent condition, coolant clean. No evidence of past or current leaks.
- Fuel system: lines secure, pumps operational, filter serviceable. No leaks.

- Electrical: additional alternator installed per Tecnam Job Card, workmanship to high standard. Output confirmed during run-up.
- Engine Rubber Mounts: minor cracks noted on forward mounts (left > right). Serviceable, monitor for progression.
- Cowling intact, secure.

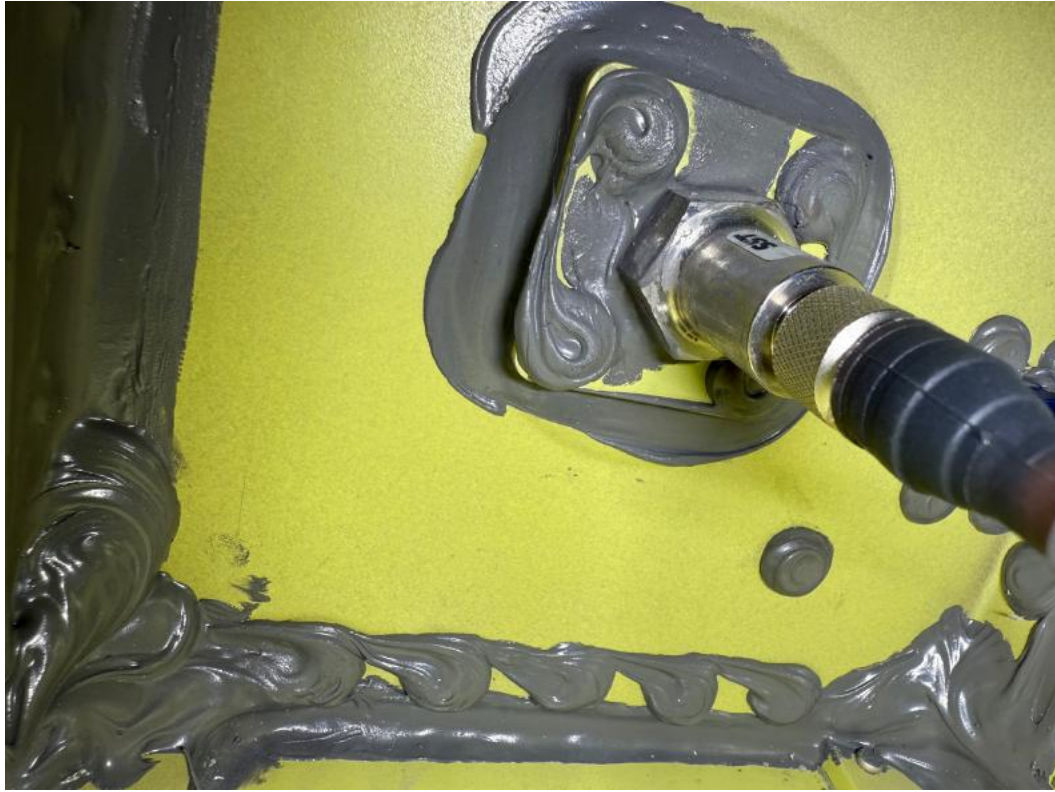
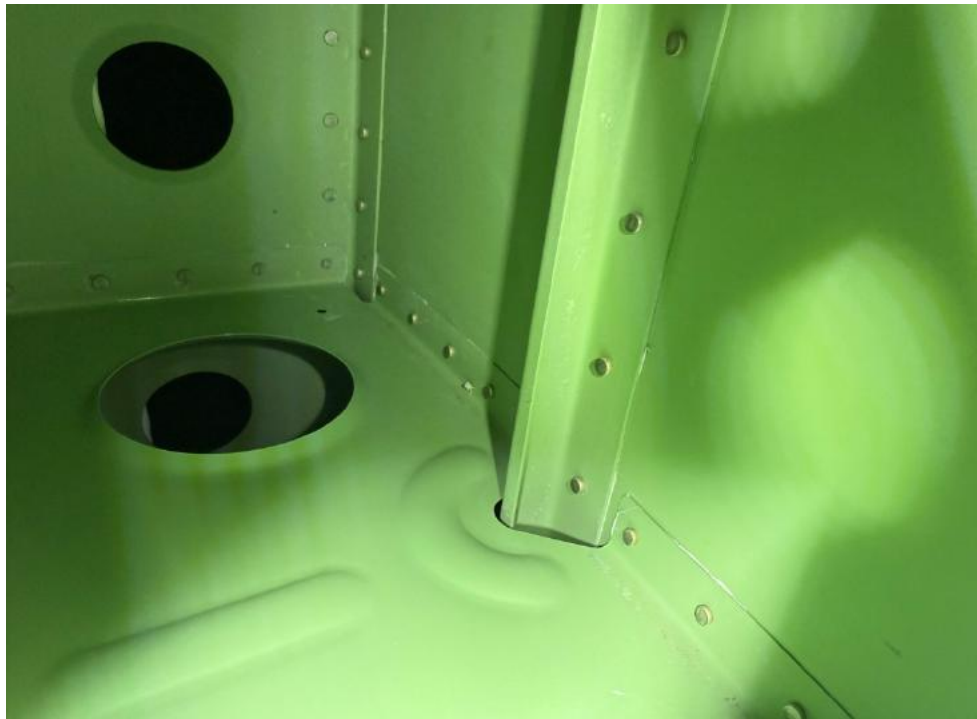
- Exterior surfaces (left & right): excellent, no scratches, cracks, or dents.
  - Ailerons and flaps: free play within limits. Linkages properly lubricated, no looseness.
  - Internal structure: no corrosion or evidence of repairs.
  - Wet-wing fuel tanks inspected: sealant intact, no cracks.
  - Interiors clean, no corrosion or staining.
  - Fuel caps in excellent condition, seals tight.
  - Vents unobstructed.
  - Carbon fiber leading edges (both wings) free of cracks or abrasions.
  - Structural bolts and spar attachments inspected: tight, corrosion-free.
-

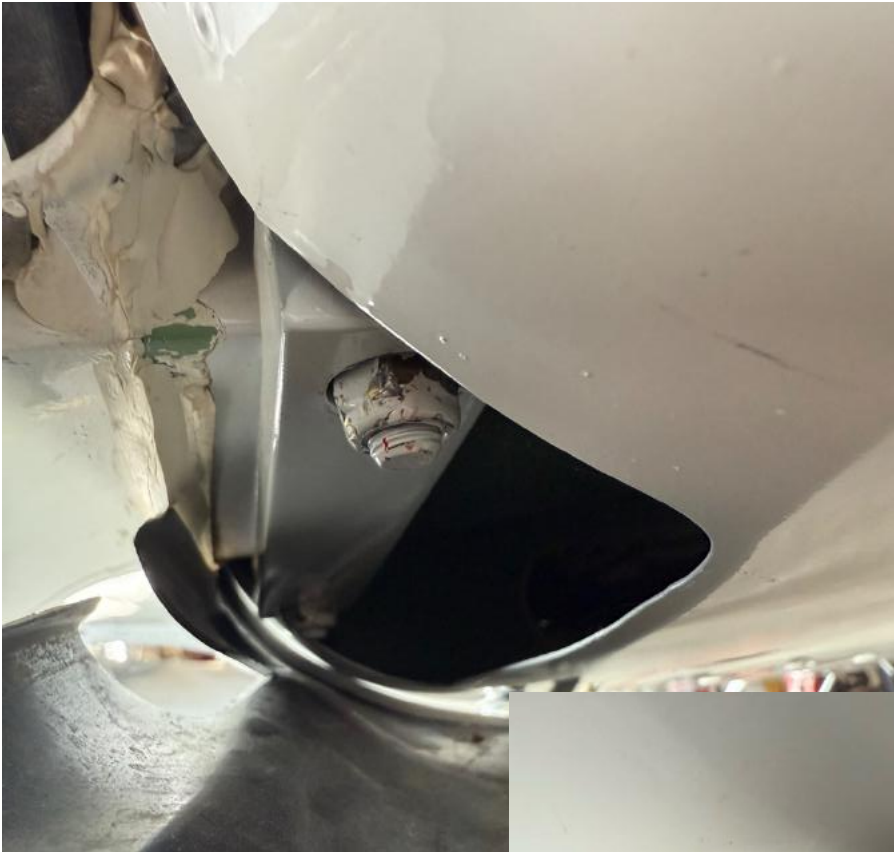
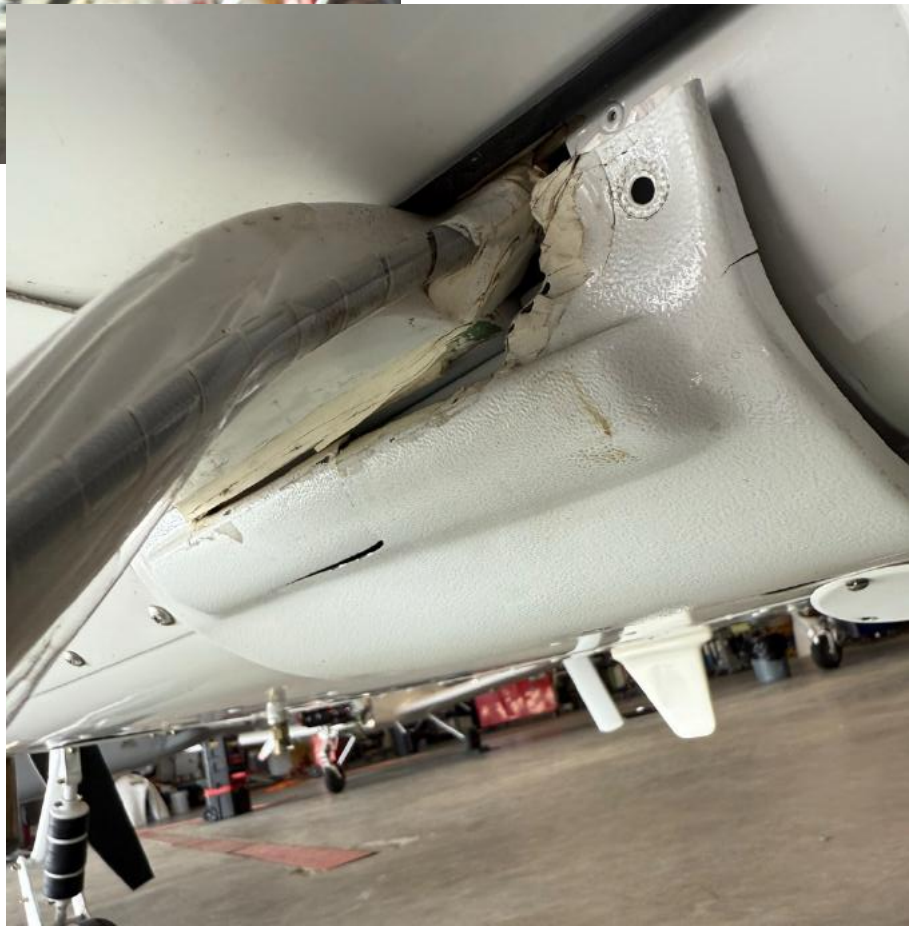
- Nose Gear: replaced in full as per logbooks; excellent condition. No looseness. Elastomer discs serviceable.
- Main Gear: both struts inspected; no cracks, deformation, or looseness.
- Decorative plastic covers show micro-cracks; cosmetic only, no effect on airworthiness.
- Brakes: Beringer system, lines intact, no leaks. Brake pads ~60% remaining. Discs smooth.

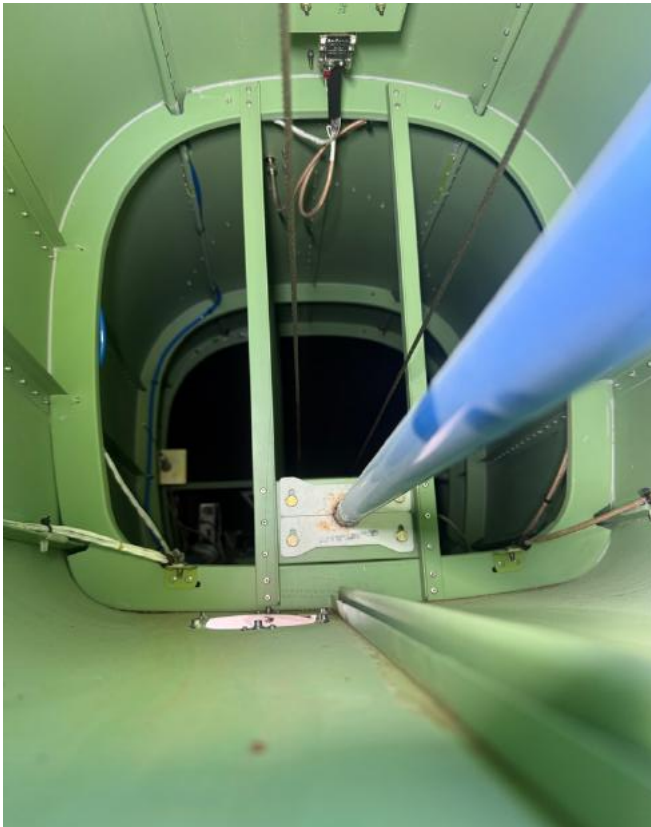
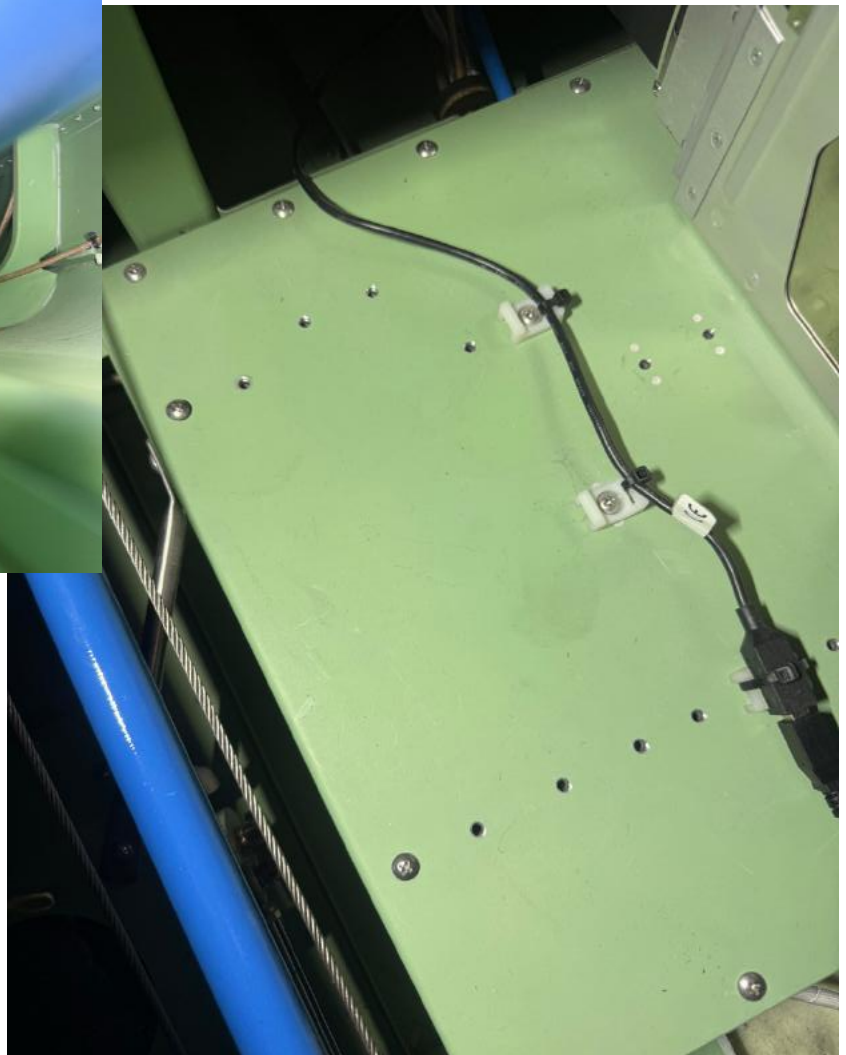
- Control cables correctly tensioned. No slack, corrosion, or fraying.
- Elevator pushrod inspected: no wear.
- Pulleys and bell cranks lubricated, no abnormal play.

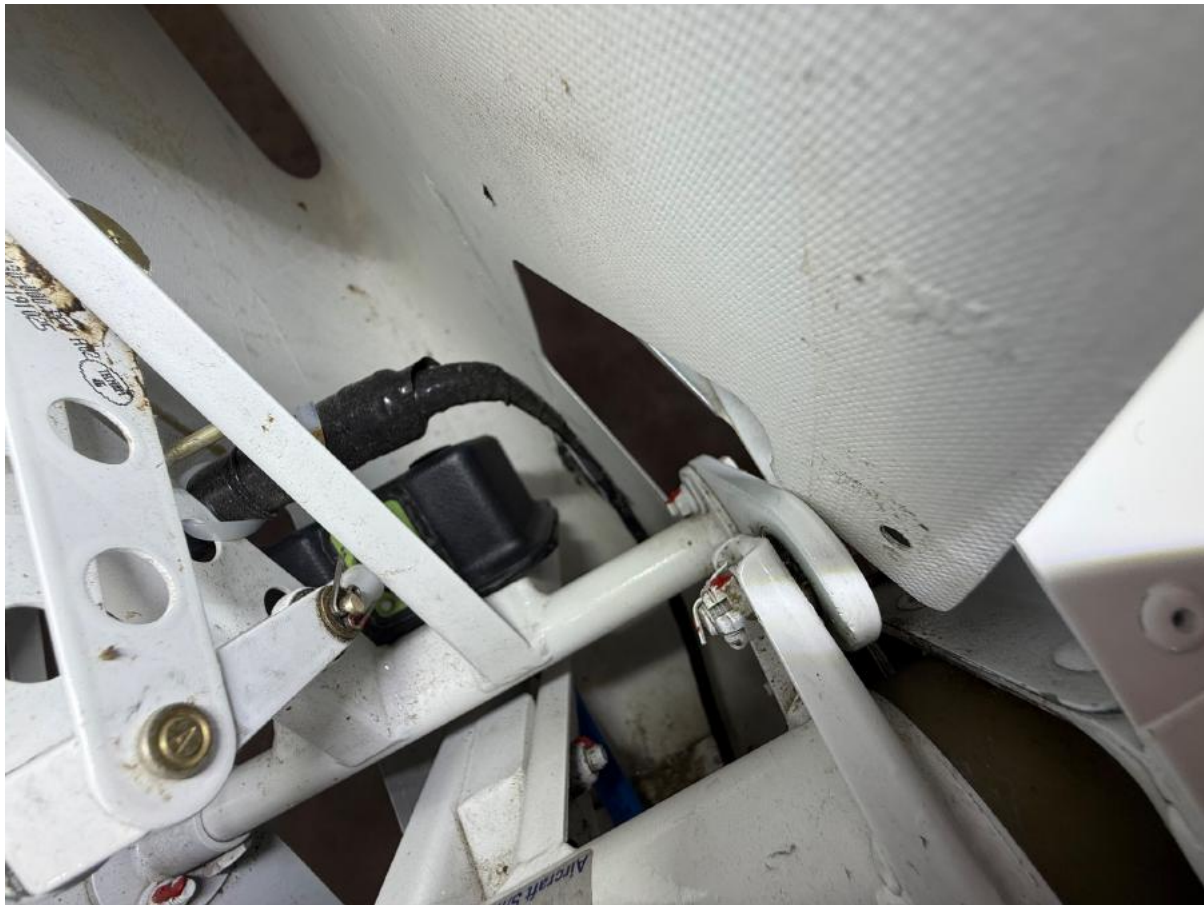
- All-moving stabilizer: no cross-axis play. Hinges and linkages secure, lubricated.
- Trim connector relocation Job Card complied with; connector now protected from water ingress.
- Surfaces clean, no dents, scratches, or corrosion.
- Trim rods tight, no backlash.
