adNote™

2008-2-6 N/M

AD NUMBER

## Garmin A/P GSM 85 Servo

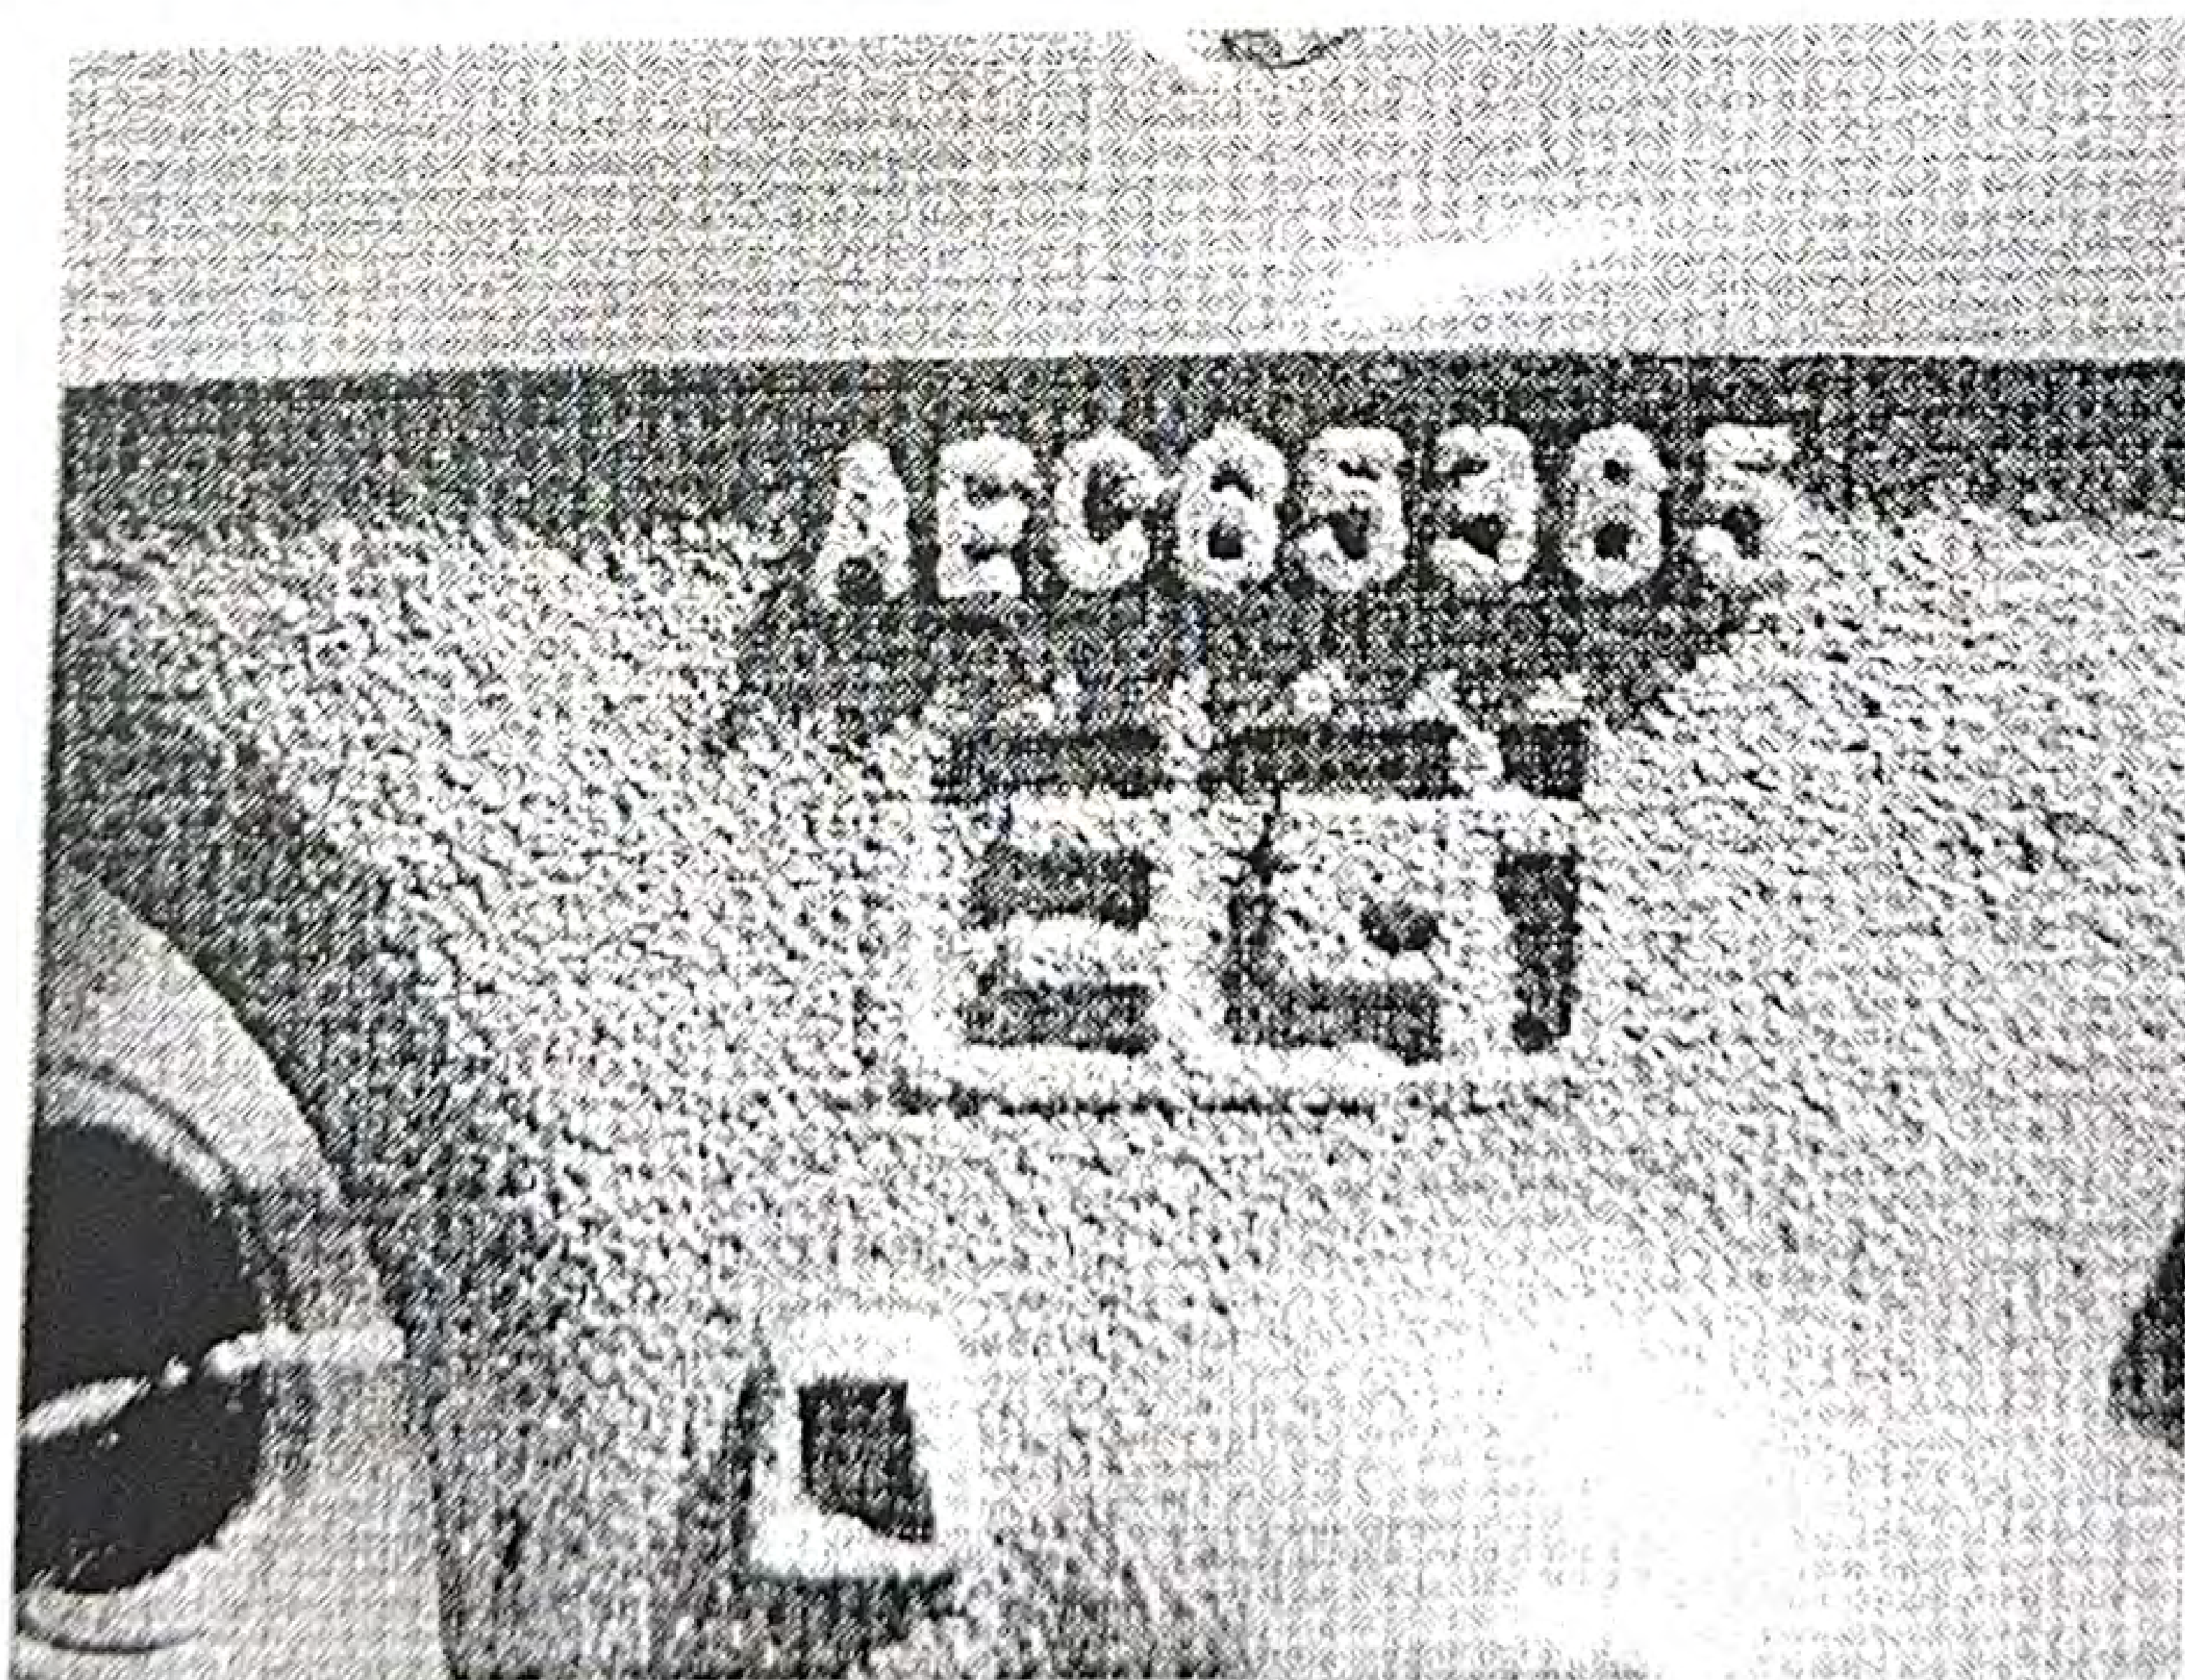
Figure 3. ↑

(ii) Look at the left-front cylinder casting.

(iii) If the casting has AEC65385, and an "O" under the ECi logo, the cylinder is P/N AEC631397. See Figure 3.

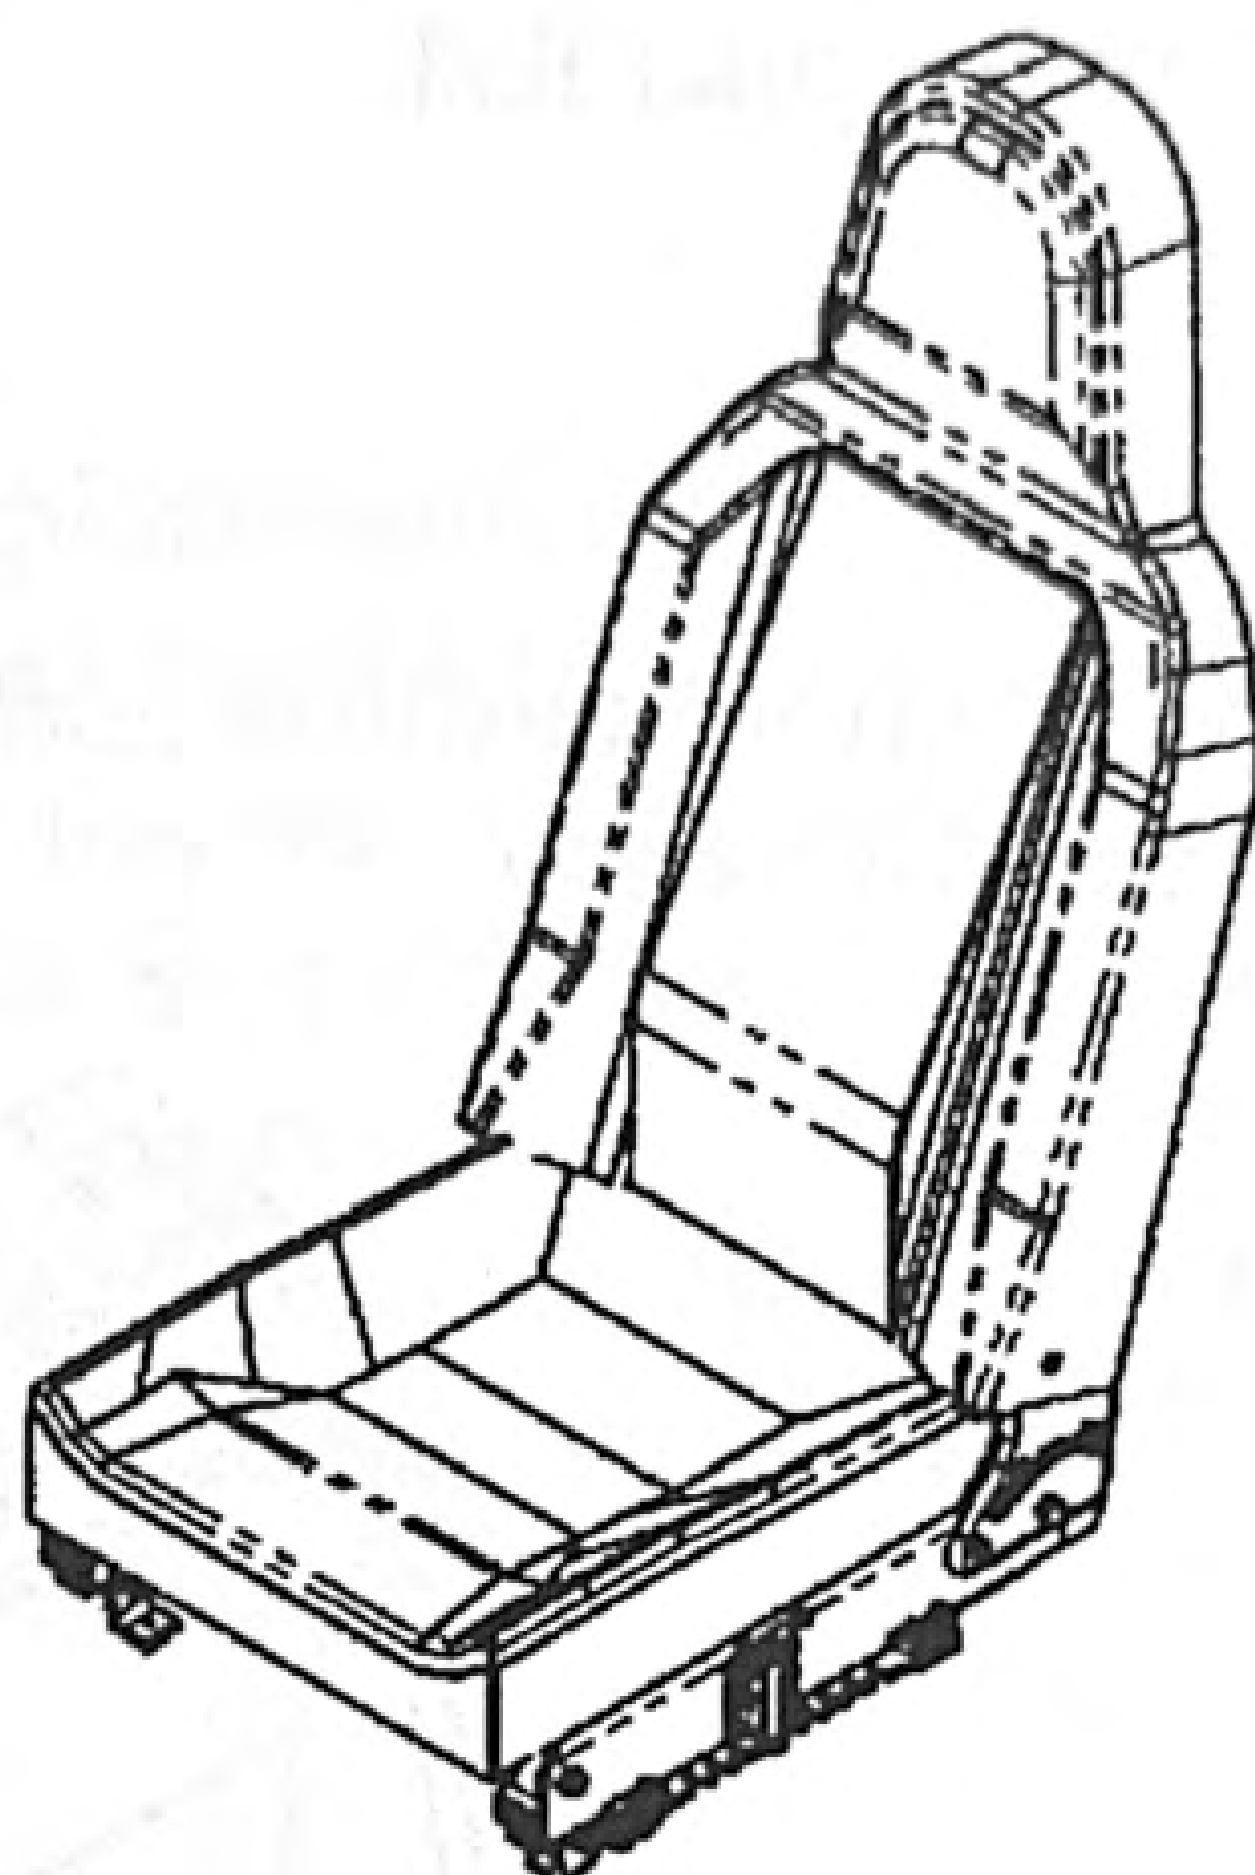
6A-0001 Front Seat  
Assy

The Front Seats, p/n 6A-0001, shall be inspected for poor condition and apparent defects as described below.

Perform a detailed inspection of the seat frame (excluding the metal frame that is imbedded in the back cushion). This assembly is an on-condition maintenance item. Therefore, inspect the metal parts of the seat, paying special attention to the fore/aft and seat recline adjustment and latch mechanisms. Contact Oregon Aero for disposition and instructions in the event any noticeable wear is detected or if any latch fails to engage properly.

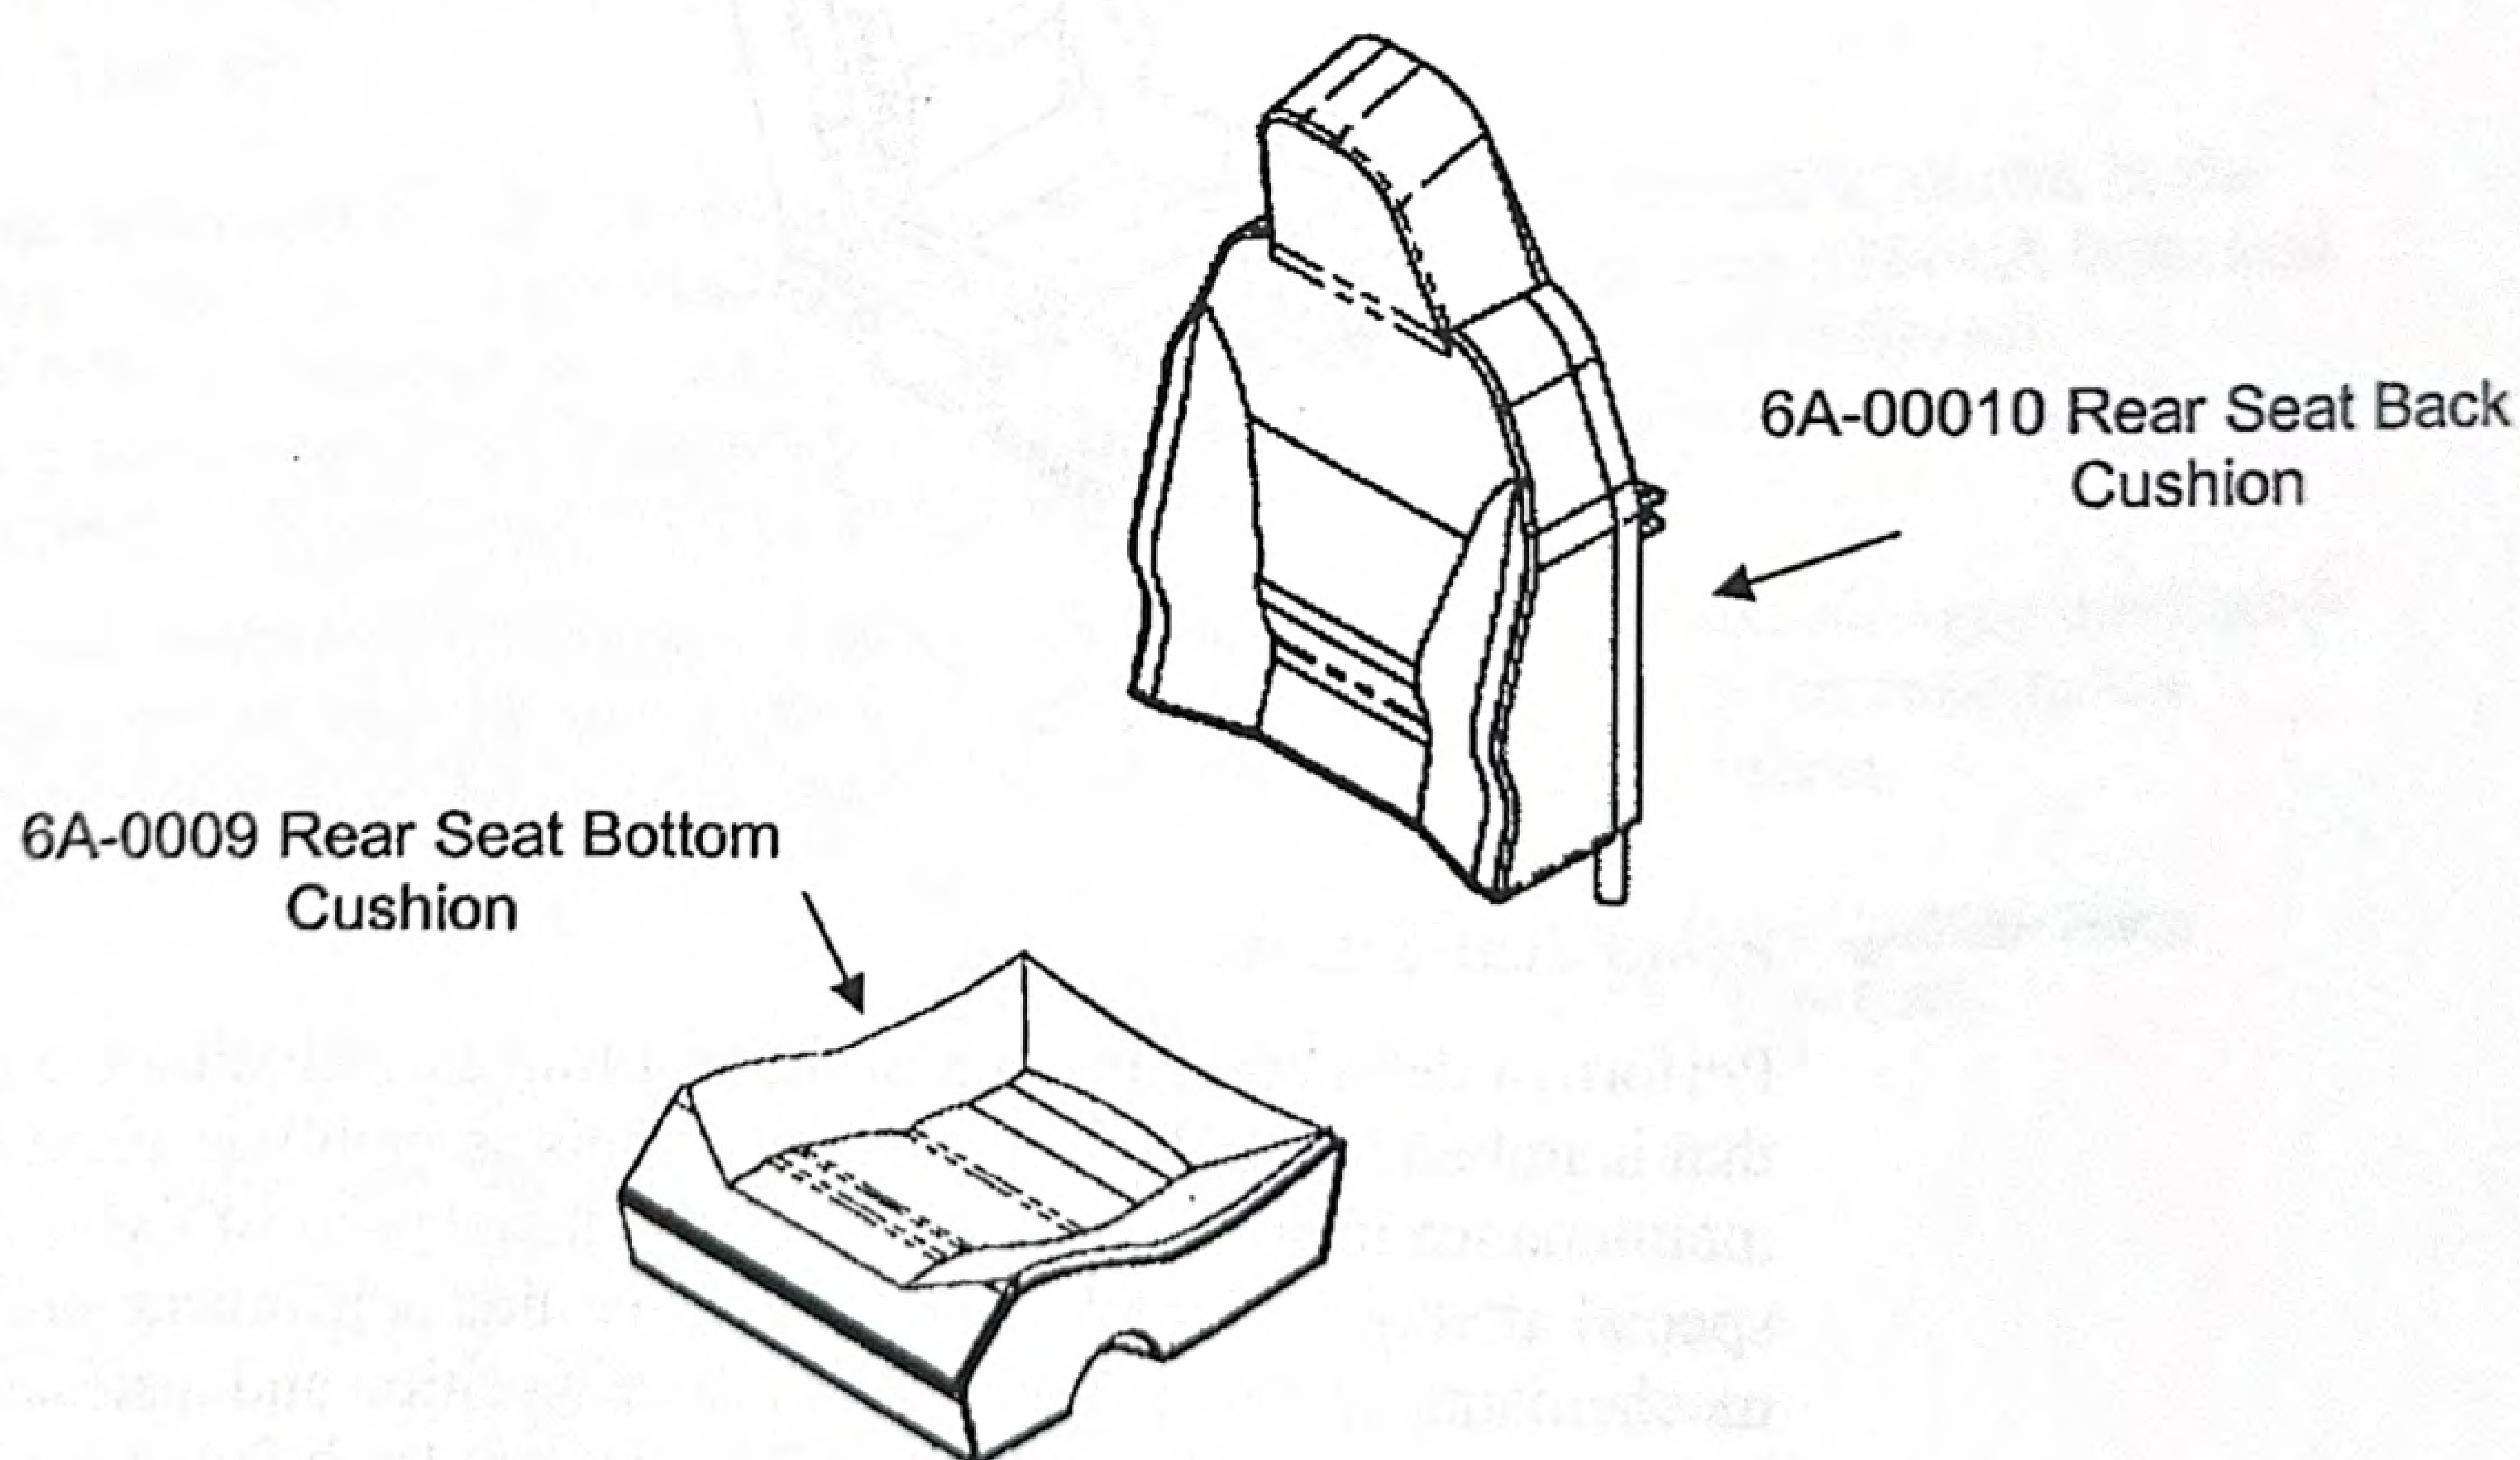
The rear seating consists of a bottom cushion and seat back, which are attached to the airframe. These are shown below.

Perform a detailed inspection of each bottom cushion to detect apparent or obvious defects, deterioration in the form of wear or irregularities that cause the seat to become worn or distorted. Replace the cushion if this wear or distortion reaches the point where the dress cover does not fit properly or the cushion develops a "lumpy" or irregular feel.
