adNote™

2008-2-6 N/M

AD NUMBER

## Garmin A/P GSM 85 Servo

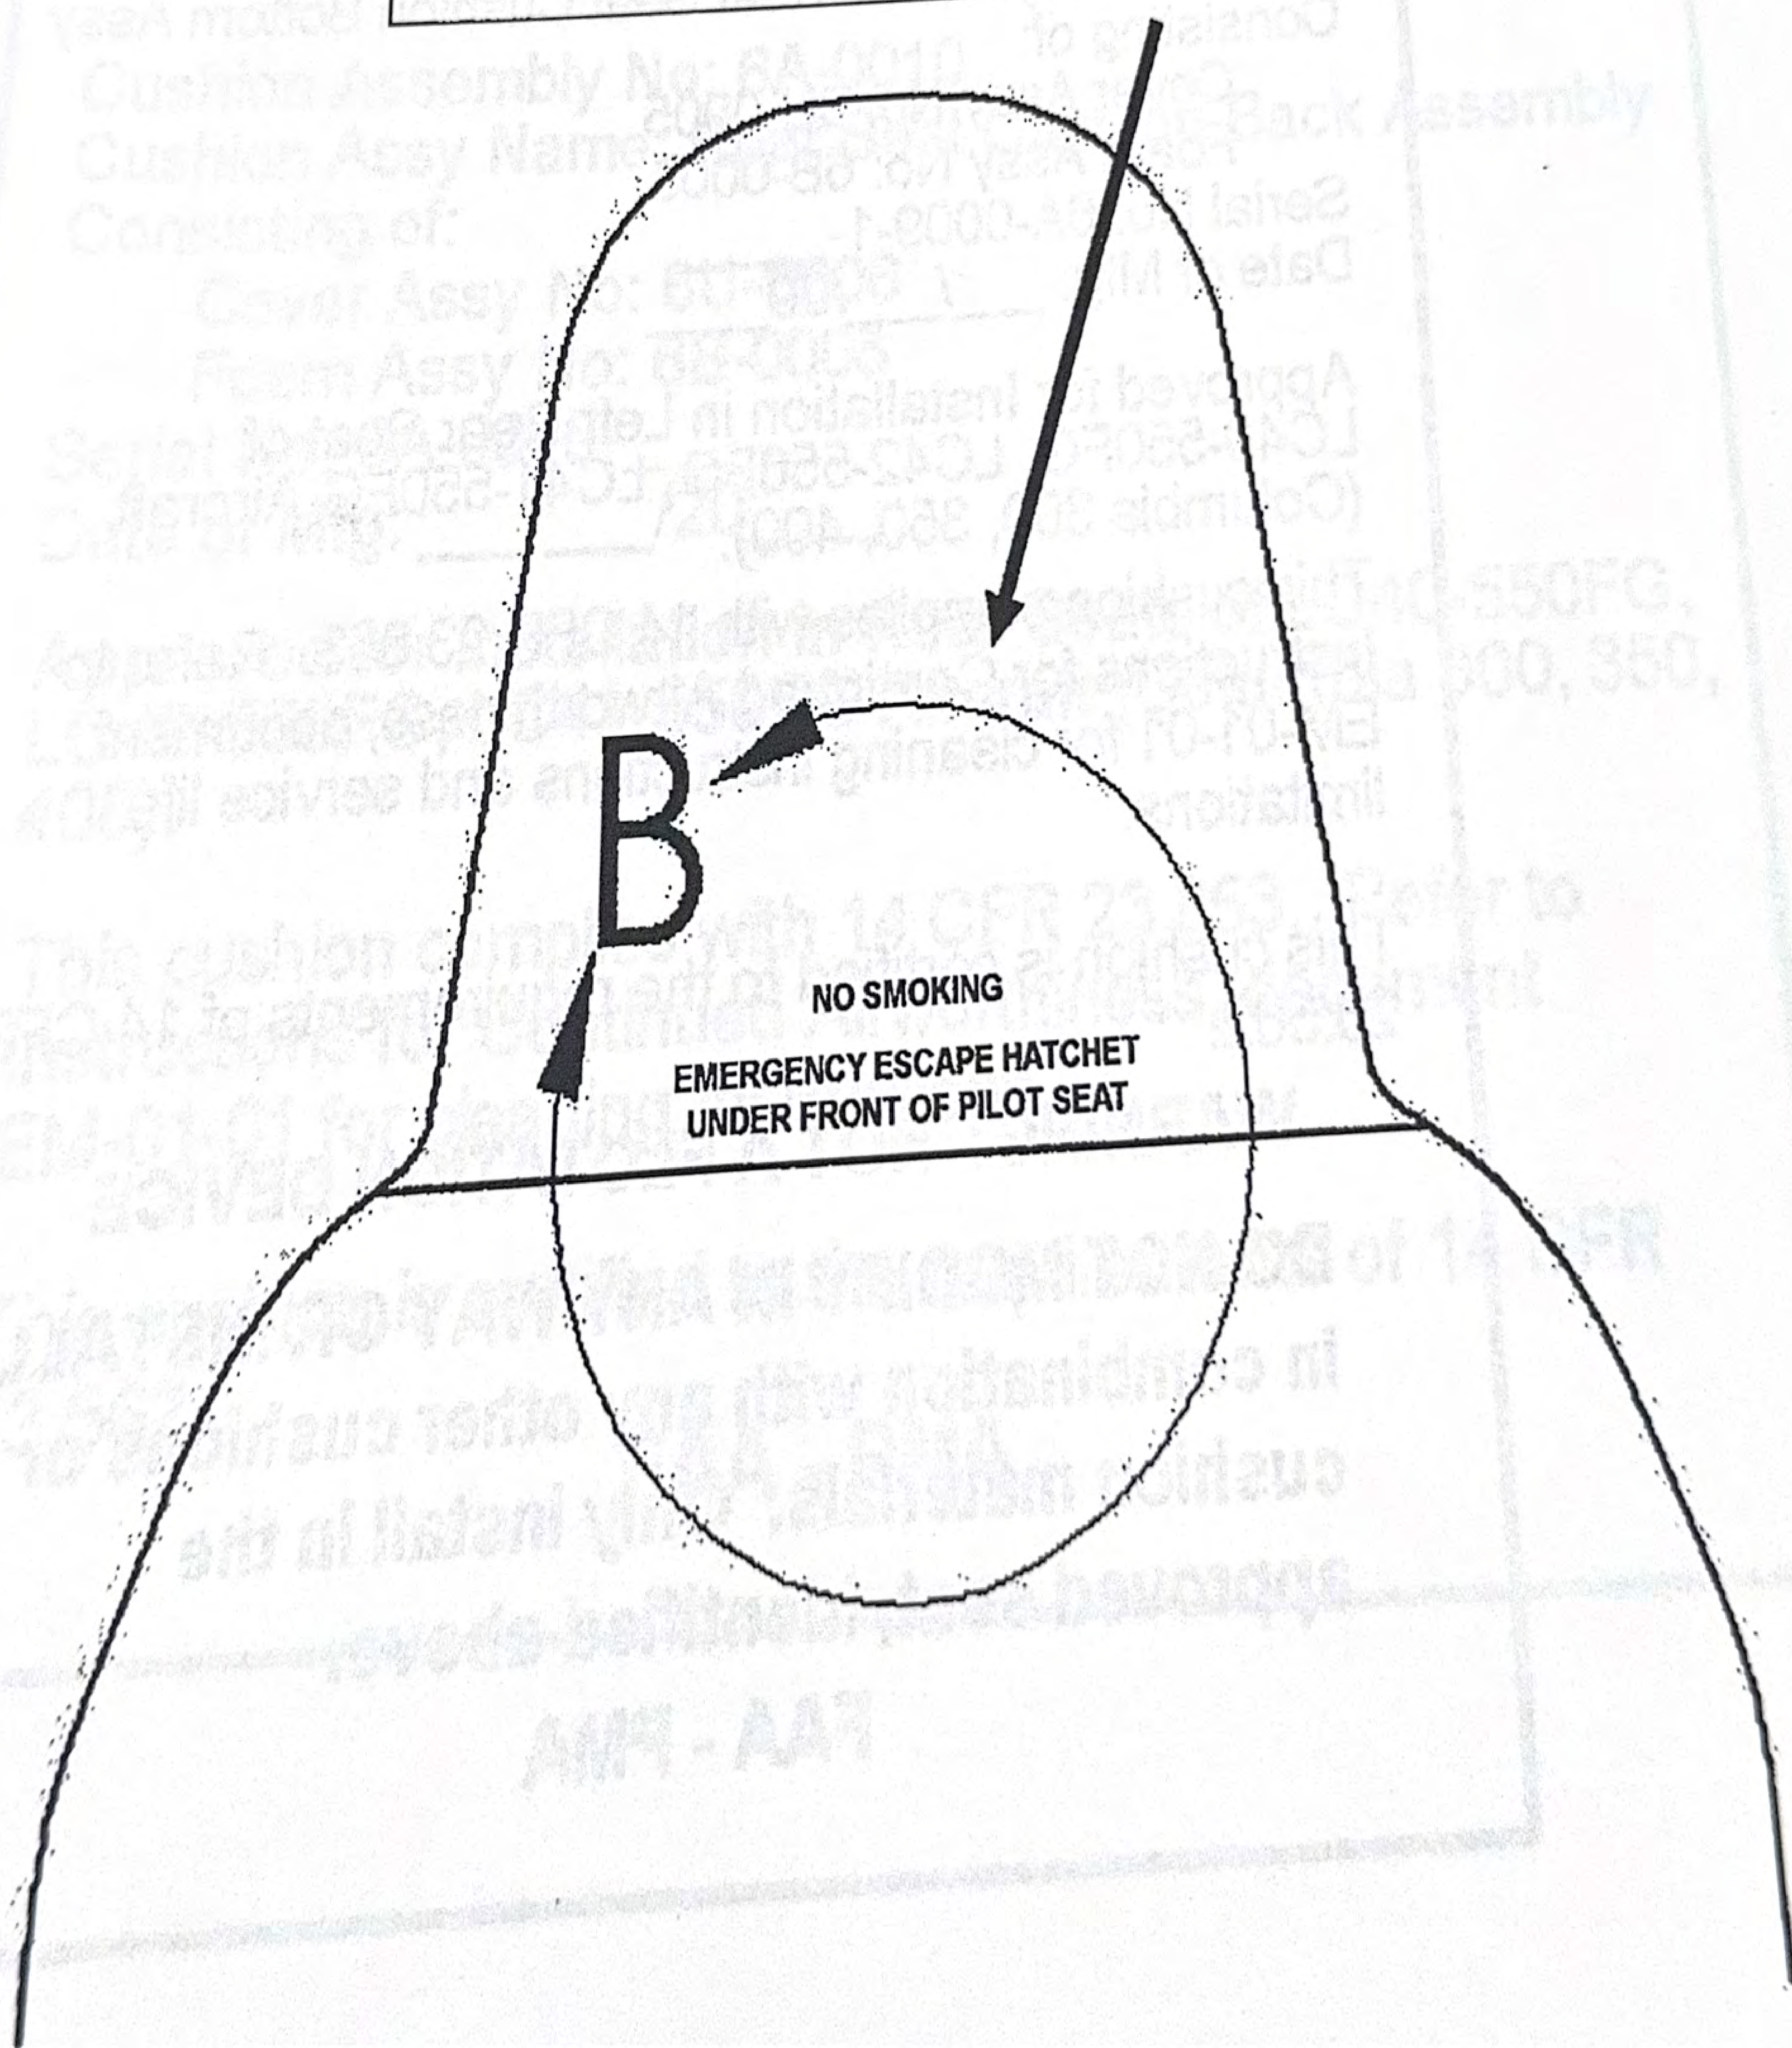
**Figure 4**

If a front seat is removed with the text shown below in Figure 4 (located on the Backrest Cover), then install the placards shown in Figure 2 and Figure 3 on the previous page:

**Embroidered text:**

**"NO SMOKING EMERGENCY ESCAPE HATCHET  
UNDER FRONT OF PILOT SEAT"**
